# FORM B – BUILDING

1551

**Town:** Lexington

**Address:** 7 Berwick Road

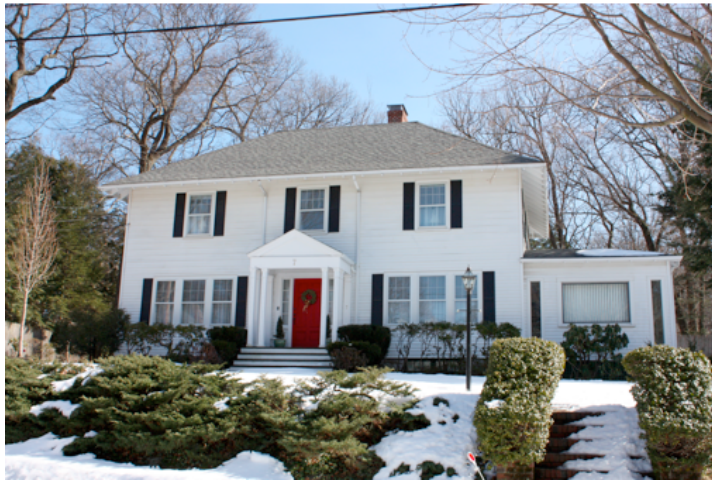
## Photograph

**Condition:** fair (due to siding)

Incorporating elements of the Colonial Revival and Craftsman styles, 7 Berwick Road is a two-story, hip-roofed dwelling sheathed in aluminum siding and set above a rubble foundation. The asphalt-shingled roof displays overhanging eaves with exposed rafter tails. The center entrance contains a paneled door flanked by sidelights and is sheltered by a pedimented entrance porch supported by two pairs of attenuated posts. On either side of the entrance is a set of three windows. The upper story of the façade is punctuated by three individual, double-hung windows containing 8/1 sash. To the west of the main house block is a single-story porch which has seen the introduction of new fenestration.
